1. REPORT NO. FHWA/CA/TL-80/23		2. GOVERNMENT ACCESSION NO.		3. RECIPIENT'S CATALOG NO.	
4. TITLE AND SUBTITLE MODEL SLAB FAULTING STUDY				5. REPORT DATE June 1980

STATE OF CALIFORNIA
DEPARTMENT OF TRANSPORTATION
DIVISION OF CONSTRUCTION
OFFICE OF TRANSPORTATION LABORATORY

MODEL SLAB FAULTING STUDY

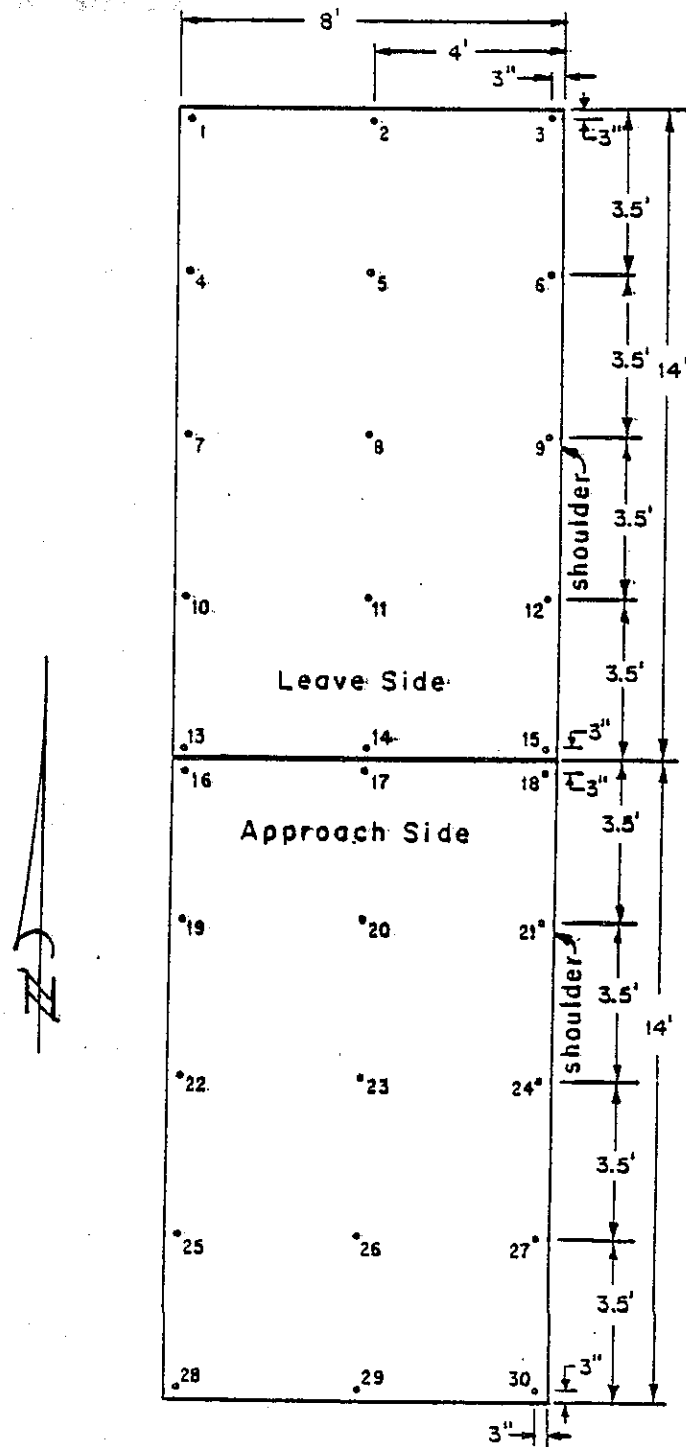
Figure 7

A set of 4 thermocouples was installed in and under each slab to monitor temperature. One of each set was placed (1) under the CTB, (2) on top of the CTB, (3) at the mid-point of the concrete slab, and (4) 1 inch under the concrete surface. Gage points were epoxied to the slab surface to measure curl, deflection, or other vertical slab movements as shown by Figure 7.

Dynamic and static deflection measurements were made with a 9,000 lb loading with the application of heat under the slab to maximize the curl. The results are shown in Table 1. Only the gage points near the joint (13 through 18) were read for static loading. Gage points 1-6 and 25-30 (see Figure 7) indicated no movement under dynamic loading. When the area under the slabs was flooded with water, a definite cushioning effect was noted with dynamic deflections reduced to about half the original values.

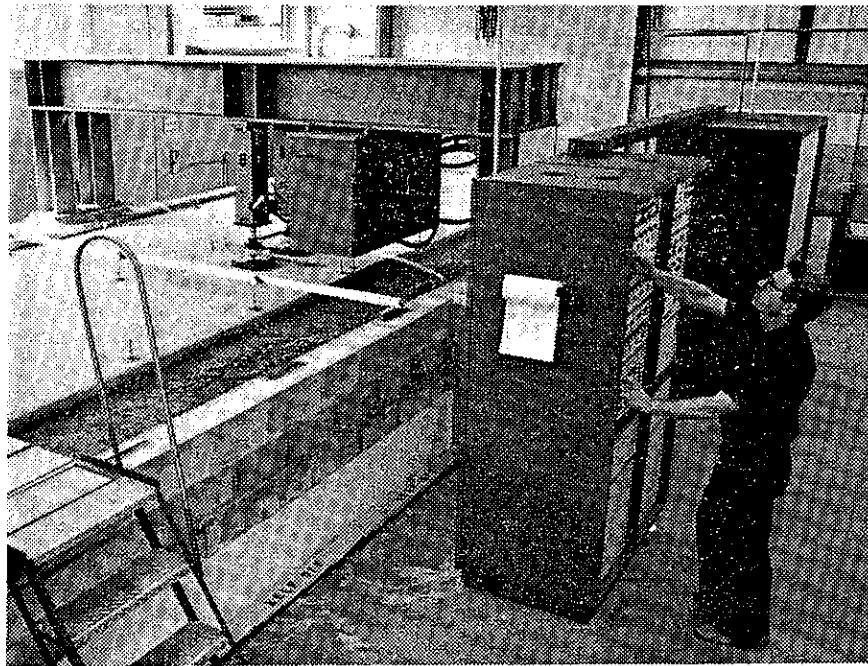
Fig. 9
Overall view of equipment and test bed.

Testing equipment was delivered and installed in late January, 1978. Overall views of the layout and close-ups of significant components are shown in Figures 9 through 12. Actuators were installed about 30 inches from the shoulder to represent wheel track loading. Steel 8 in. x 10 in. blocks with thin neoprene bearing pads approximating the tire print of a single truck wheel were used to distribute loads. The reaction frames were designed to deflect less than 0.005 inch when a 10,000 lb load was applied. In Figure 11, the near actuator applies the first load on what will be referred to as the "approach" side of the joint. The second actuator applies a load to the "leave" side of the joint.

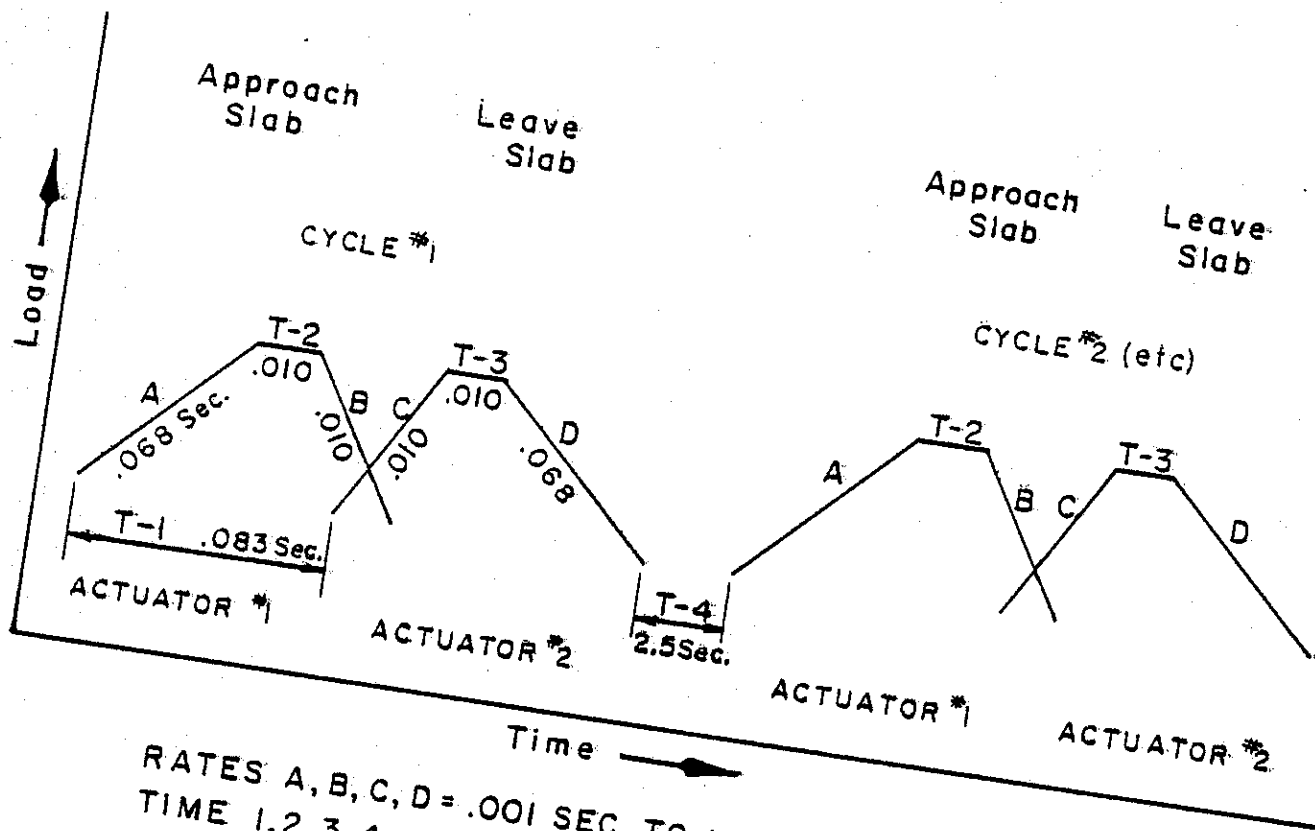
LOADING AND TIMING RATES

Considerable experimentation was required to establish the desired loading rates and time sequences. All functions were programmed through a dual digital ramp generator with adjustment based on load cell feed-back information shown digitally and on an oscilloscope. The programmed information was as shown in Figure 13. The times T2 and T3 were entered to prevent overshoot of the planned loading rate, and proved to be quite satisfactory as observed on the oscilloscope. Initially, loading was applied at 9,000 lbs on each actuator. A preload of 100 to 300 lbs was kept on the actuators to prevent loss of contact with the base plate.

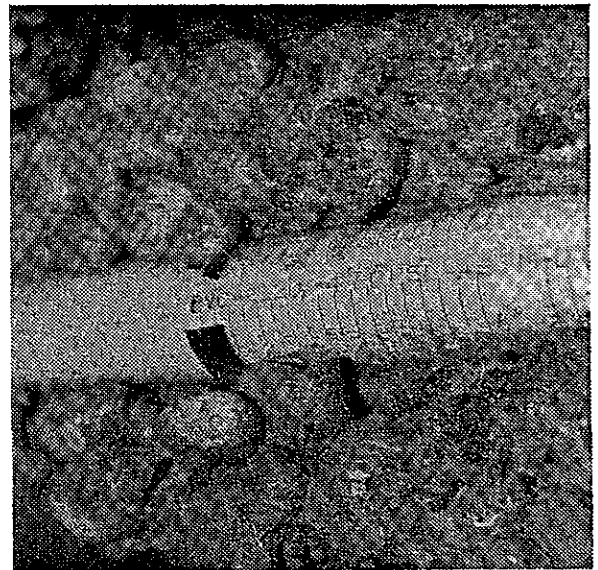
Fig. 21
Slotted pipe in porous concrete.

tank. A pressure of approximately 20 psi was used. Initial tests indicated significant reductions in deflection. On the approach side, deflections decreased from 0.028 in. to 0.018 in., and on the leave side, from 0.012 in. to 0.008 in., all under a 9,000 lb load. However, pumping with water present removed some of the grout and fines from under the approach side and allowed deflections to increase greatly, from 0.018 in. to about 0.060 in., (after approximately 1.0 MC) indicating the creation of a large void. Deflections on the leave side have remained unchanged, which indicates some measure of success.
